Manhole Inspection Summary

Manhole # S25C__049MH

Location Address: **MULBERRY ST** Cross Street: **CARROLLTON AVE**

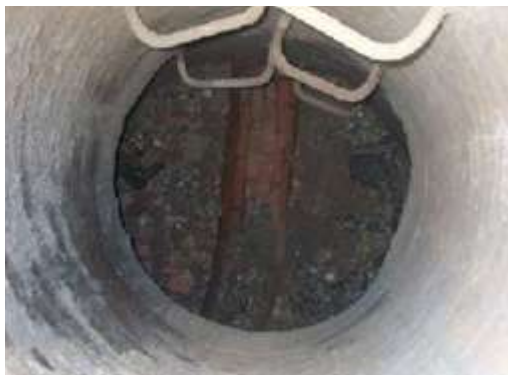
Top View

Comments **ADDED NEW 012, I3, AND I6 PHOTOS 4-28-09**
TOOK NEW TOP VIEW PHOTO - COULD NOT SHOW PIPE CONNECTIONS DUE TO
CHANNEL JUNCTION OFFSET CONDITION 4-29-09.
